**SAS Superstructure**

**Daily Diary Report by Bid Item**

Contract No.: 04-0120F4

**04-0120F4  
04-SF-80-13.2/13.9  
Self-Anchored  
Suspension Bridge****Weather**

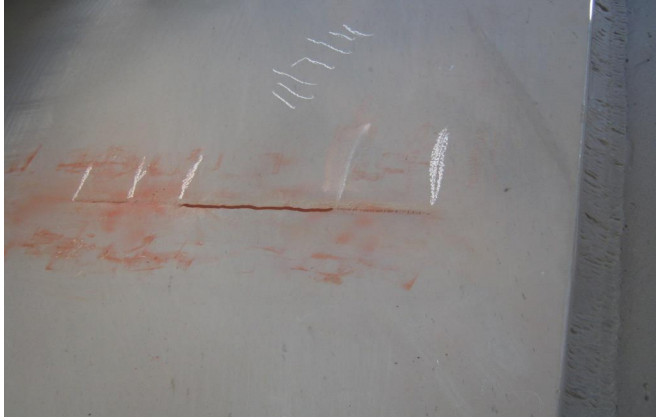
I also accompanied Warren and Roman to the West loop to get a little familiar with the operations at that location. While walking in and around this area, I noticed a visual indication on a weld in the West jacking frame. Upon closer look at the weld, it appeared to be a crack. I called METS inspector Danny Reyes, and asked him to take a look at the weld. He was also of the opinion that it appeared to be a crack. He notified ABF QC, and they tested the weld by magnetic particle testing (see attached photos). I called Roman to let him know that it does appear to be a crack, and he mentioned that he would print out the shop drawings for the weld in question. General information of the weld in question are listed below:

- It is a butt joint on the North side of the jacking frame.
- It is located 760mm from the top of the jacking frame.
- It starts about 120mm from the edge of the frame (the edge closest to the jacking saddle).
- The main indication is 190mm in length, then there is a gap of 50mm with no indication, then there is another indication 50mm in length.

Close-up view of the weld indication in the West jacking frame

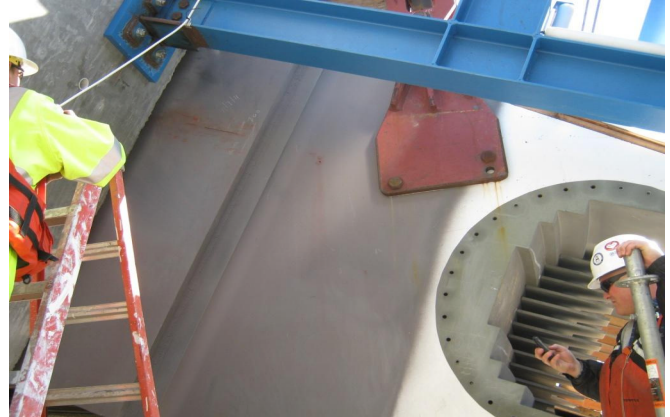
North side of the West jacking frame with weld indication
